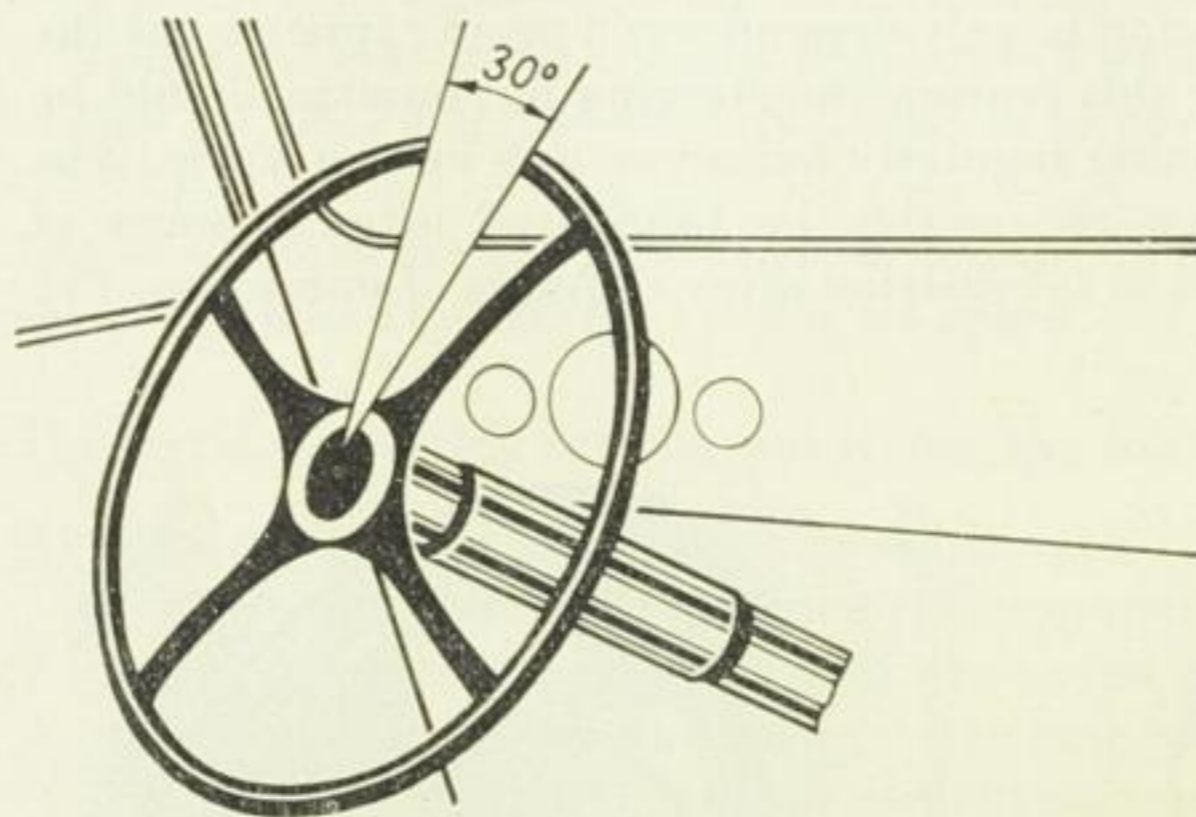
the maximum amount is 30 degrees. This is roughly equal to the width of a hand (Fig. 234).

Fig. 234. Maximum permissible lost motion at the steering wheel of tractors 30°
