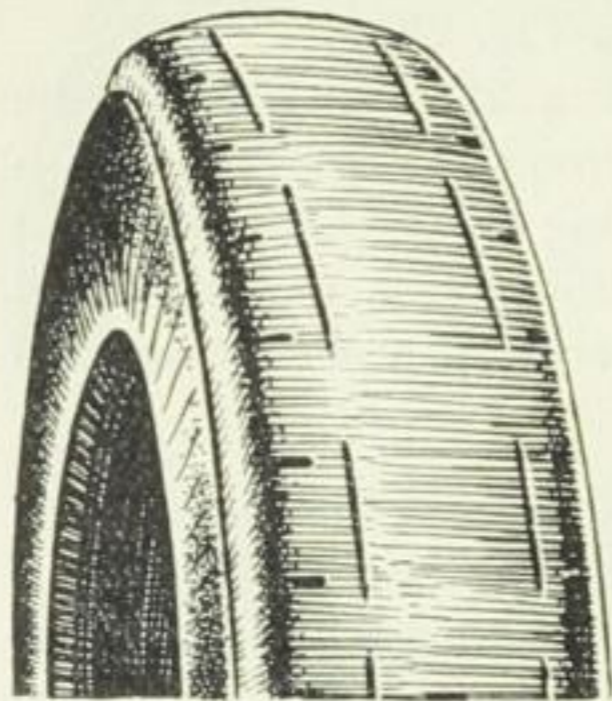
Fig. 285 A

Normal wear and tear

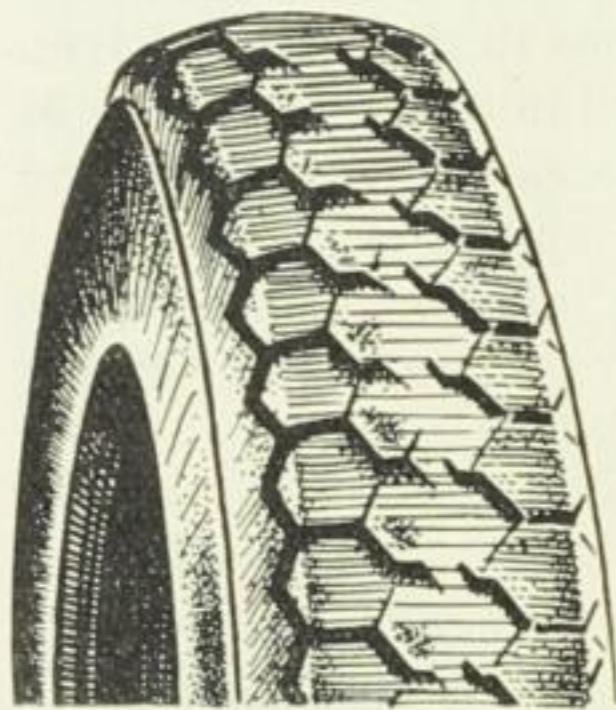
Fig. 285 B

Tread worn out

Insufficient inflation pressure

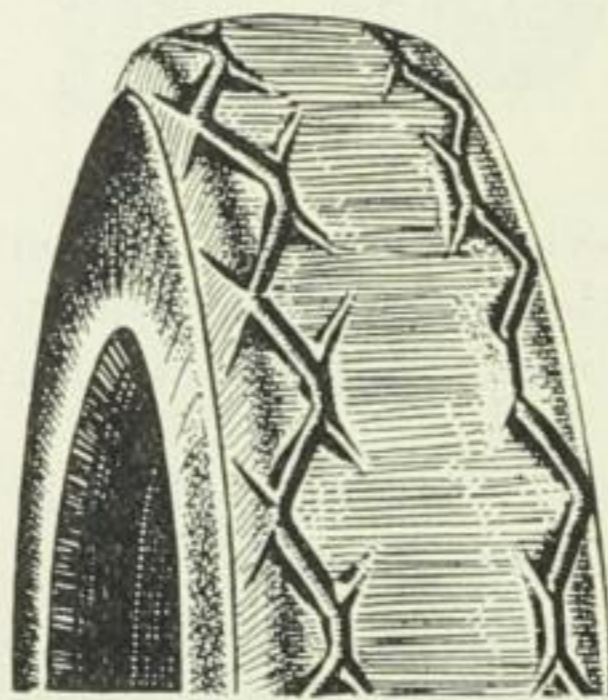
Fig. 285 C

Wear due to grinding action of tyres

Careless driving of the tractorist
